Working on Boeing Aircraft – Peter Marosszeky FRAeS

Boeing Story 1: The focus of this story is the work of the Boeing Aircraft on Ground (AOG) team and the remarkable feats of recovery and ingenuity in the repair and return to service of aircraft that have been involved in accidents. Over the years I have had the good fortune of being associated with the recovery of other broken aircraft. This was the first and most memorable event, the aborted take-off and

subsequent crash of Pan Am flight 81201 in Sydney, December 1st. 1969.

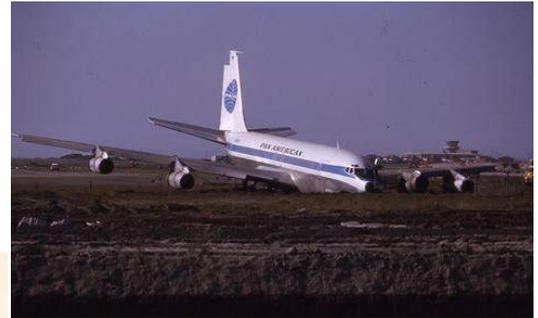
12. The probable cause of the accident was that, in the circumstances of an abandoned take-off, the aircraft could not be brought to a stop within the nominally adequate runway length because of an error in the calculation of load, a reduction in wind velocity from that forecast and the use of rolling start and braking techniques which would not ensure most effective use of the available runway length.

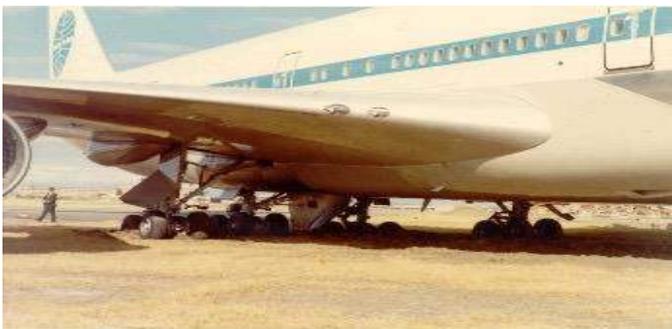
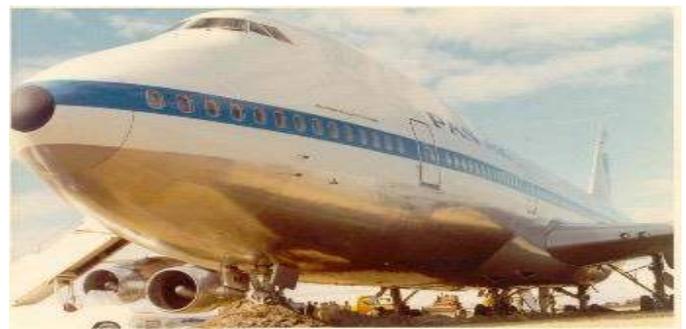
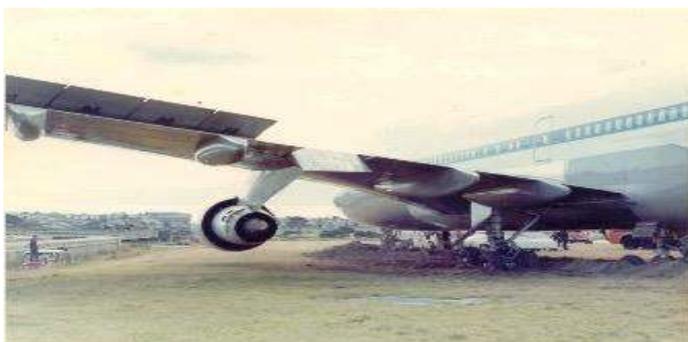
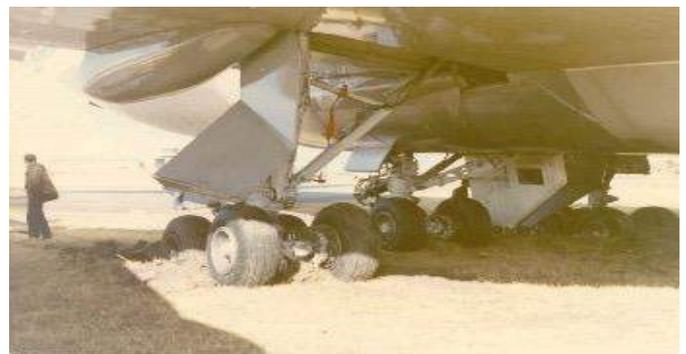
Boeing Story 2: This experience proved valuable two years later when one of the first Pan Am 747s (N652PA) serving Sydney landed long and became bogged off the cross-wind runway, just short of a major sewer viaduct narrowly avoiding a potential disaster. The strength of the 747 design meant there was no structural damage and we only had to replace two damaged nose wheel tyres.
