Working on Boeing Aircraft – Peter Marosszeky FRAeS

Boeing Story 1: The focus of this story is the work of the Boeing Aircraft on Ground (AOG) team and the remarkable feats of recovery and ingenuity in the repair and return to service of aircraft that have been involved in accidents. Over the years I have had the good fortune of being associated with the recovery of other broken aircraft. This was the first and most memorable event, the aborted take-off and

subsequent crash of Pan Am flight 81201 in Sydney, December 1st. 1969.

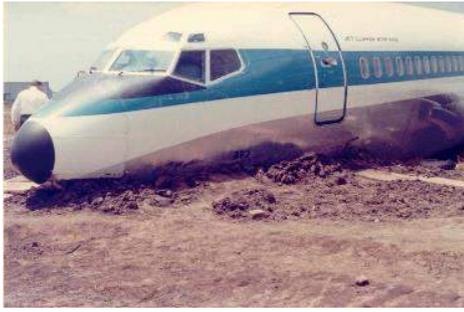
The aircraft was a Boeing 707-321B, Serial Number 20029, and had been owned and operated by Pan Am since its manufacture. The aircraft was delivered to Pan Am on the 4th. March 1969 and the Certificate of Aircraft Registration was issued on the 27th. March 1969. The aircraft had flown a total of 3,044 hours since new and had flown 930 hours since the last equalised service and 79 hours since the last Terminal Service. There was no evidence in the aircraft records of any engineering deficiencies which could have been relevant to the accident and all reported deficiencies had been corrected.
